# Uniform Mitigation Verification Inspection Form

| Owner Name: Schooner Bay Condo | | Contact Person: Renee |
| Address: 109 Paradise Harbour Blvd. | | Home Phone: |

Inspection: 070313mc

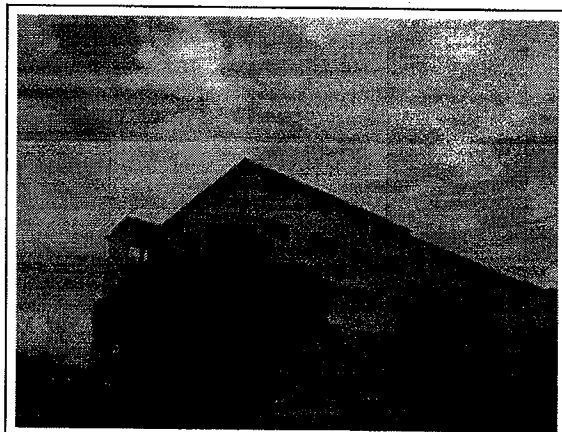
- ☒ E. Structural      Anchor bolts structurally connected or reinforced concrete roof.  
☐ F. Other: \_\_\_\_\_  
☐ G. Unknown or unidentified  
☐ H. No attic access

Item 4  
Reinforced flat concrete roof deck

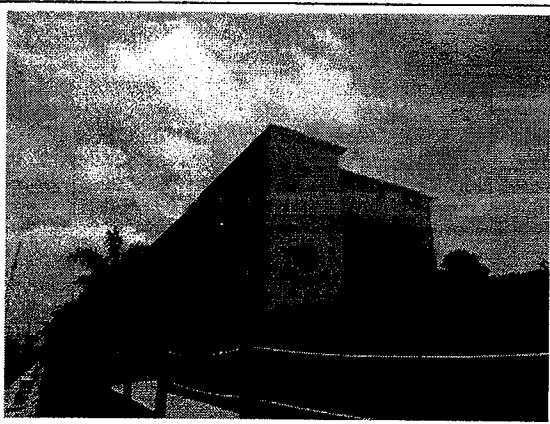
- ☐ A. Hip Roof      Hip roof with no other roof shapes greater than 10% of the total roof system perimeter.  
Total length of non-hip features: \_\_\_\_\_ feet; Total roof system perimeter: \_\_\_\_\_ feet
- ☒ B. Flat Roof      Roof on a building with 5 or more units where at least 90% of the main roof area has a roof slope of less than 2:12. Roof area with slope less than 2:12 \_\_\_\_\_ sq ft; Total roof area \_\_\_\_\_ sq ft
- ☐ C. Other Roof      Any roof that does not qualify as either (A) or (B) above.

Item 5  
Flat roof design

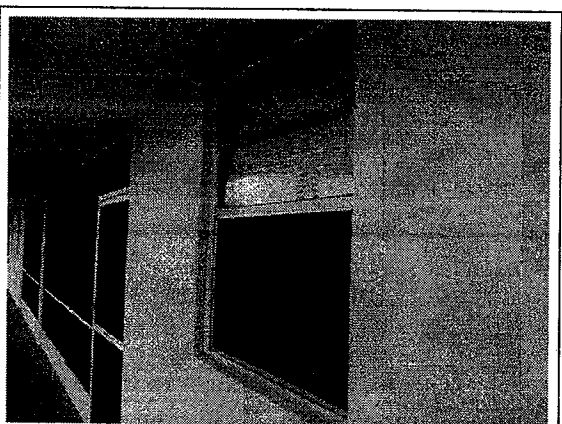
| Opening Protection Level Chart<br>Place an "X" in each row to identify all forms of protection in use for each opening type. Check only one answer below (A thru X), based on the weakest form of protection (lowest row) for any of the Glazed openings and indicate the weakest form of protection (lowest row) for Non-Glazed openings. | | Glazed Openings | | | | Non-Glazed Openings | |
|---|---|---|---|---|---|---|---|
| X | No Windborne Debris Protection | <input checked="" type="checkbox"/> | <input type="checkbox"/> | <input type="checkbox"/> | <input type="checkbox"/> | <input checked="" type="checkbox"/> | <input type="checkbox"/> |

Item 7  
Multiple windows without opening protection

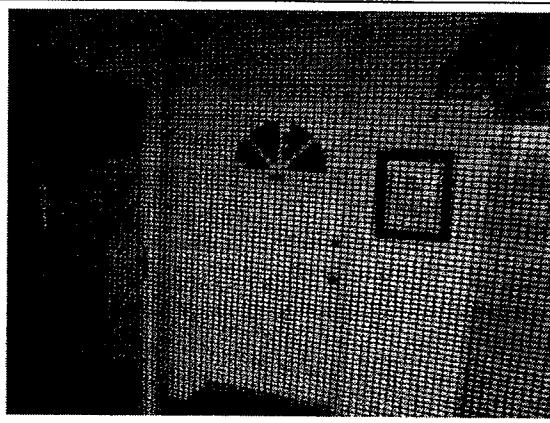
Item 7  
Doors not labeled as rated
